Skaneateles Lake Watershed
Composting Toilet Project

Helping America's Small Communities Meet Their Wastewater Needs
Spring 2004 Volume 5 Number 1

Rich Abbott

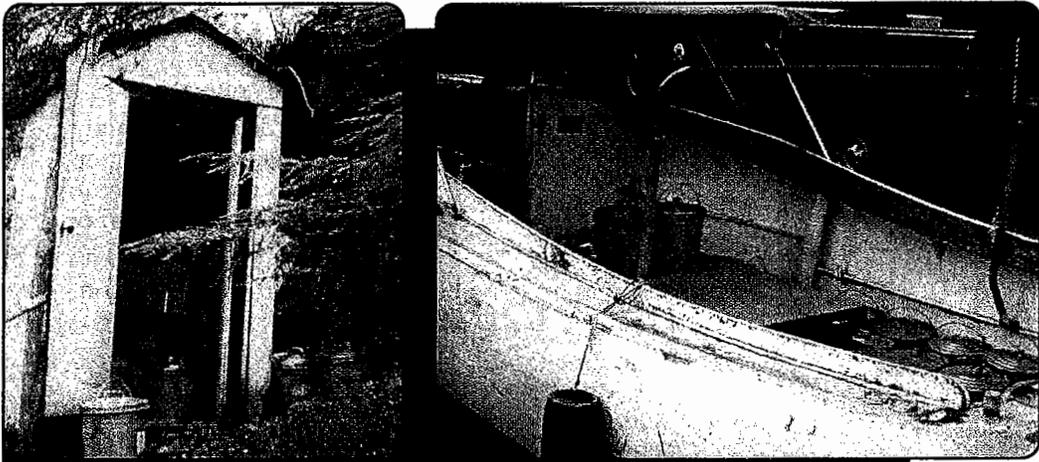
Prior to the composting toilet project, many lakeside residents in Skaneateles relied on a pail pick-up service initiated in 1908 to dispose of their household sewage. Five-gallon pails of raw sewage were transported by truck and boat to Syracuse. Photos by Rich Abbott.

city were placed under a hinged box seat in the privy and collected on a weekly basis by city personnel (City of Syracuse Department of Water, 1912). Two full-time and two seasonal employees were responsible for collecting and sealing full pails and replacing them with clean, disinfected pails. The full pails were transported to a holding tank on city property and periodically pumped out by a licensed waste hauler.
